# Pre-Purchase Building and Pest Inspection Report (PPBPIR)

1/95 Barbaralla Drive Springwood Qld 4127

Monday, 23 March 2026

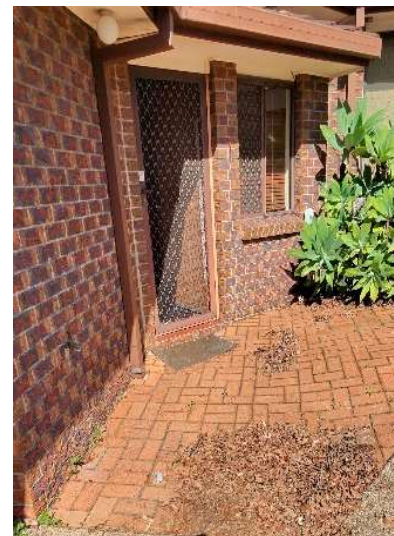
Some of the weep holes sit too close to ground level, leaving these areas vulnerable to water entry and termite attack. Weep holes should ideally have 75 millimetres of ground clearance to help prevent decay and potential termite entry. Consideration should be given to an annual inspection or treatment in accord with "Australian Standard 3660" be carried out to reduce the risk of further attack.

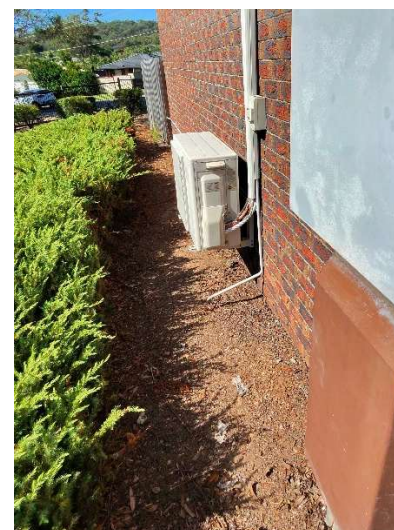
It is suggested that the sheds, tanks and gardens and foliage is kept away from the external wall to minimise the chance of water and termite infestation.

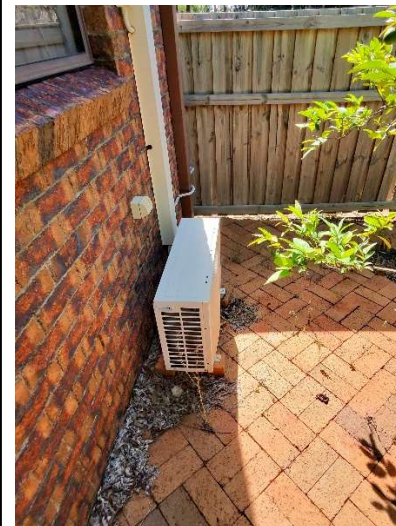
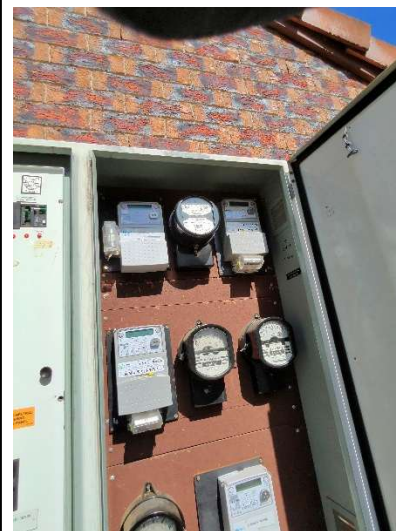
Recommend Electrical inspection- Wires not in conduit

Recommend Electrical inspection- Electrical earthing issues

The smoke alarms appeared to be inadequate and do not appear to comply with the current legislation.

We recommend connecting the air conditioning services discharge to the storm water system, this area is highly conducive to termites. Repairs recommended.

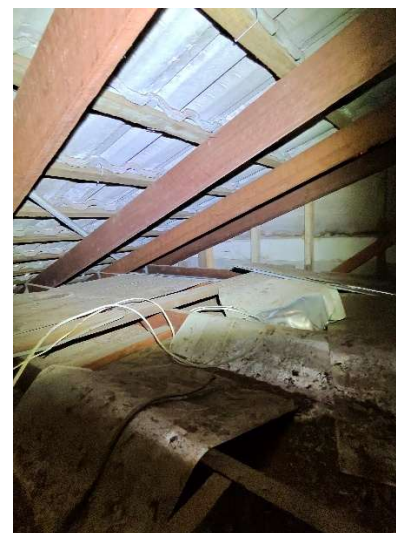
High heat readings were recorded with the thermal imager that are consistent with poor application of insulation. Observation made with a thermal camera.

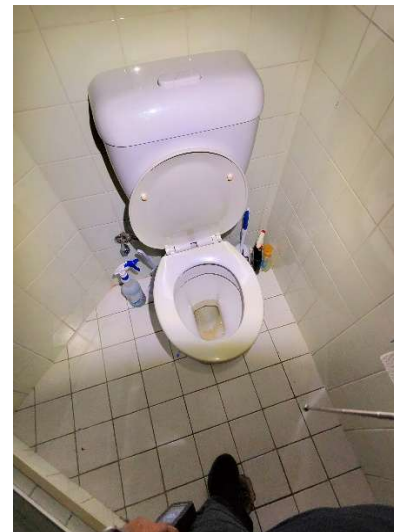
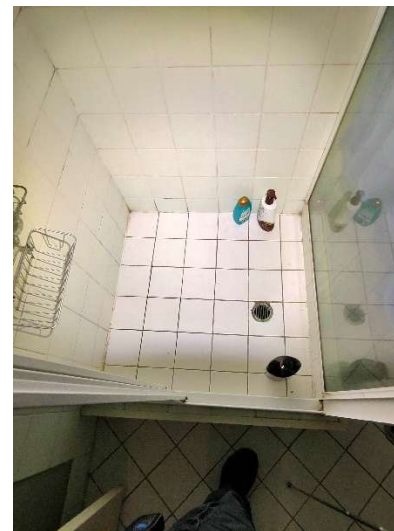
Efflorescence discoloration was observed on the grout of the bathroom wet area floor tiles. This condition is typically caused by moisture moving through the grout, which leads to the deposition of salts on the surface as the water evaporates. While efflorescence is often a cosmetic issue, it can also indicate underlying moisture problems, such as leaks or inadequate waterproofing. It is recommended that a licensed plumber conduct additional inspections to assess the potential cause and ensure the integrity of the plumbing and waterproofing systems.

Check for evidence (Form 16) ( or equivalent) to ensure all wet areas have been constructed in accordance with AS.3740-2004
